## JunglePAX – Release Notes

Firmware Package p/n 90000-01  
Version: 1.18.29263  
Release Date: October 19<sup>th</sup>, 2020  
Type of Release: Production Release

### Lentronics JunglePAX

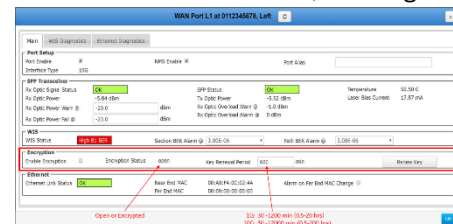
### 3. WAN Encryption for improved confidentiality

Encryption of all traffic carried over the WAN is now supported. This is a licensed feature, allowing users to encrypt individual fiber optic segments on any of the 12 JunglePAX WAN ports. After enabling Encryption on both sides of a WAN link, public/private keys will automatically roll based on the administrator's configuration (30 min to 200 hrs), or keys can be manually renewed on each segment via the Web User Interface.

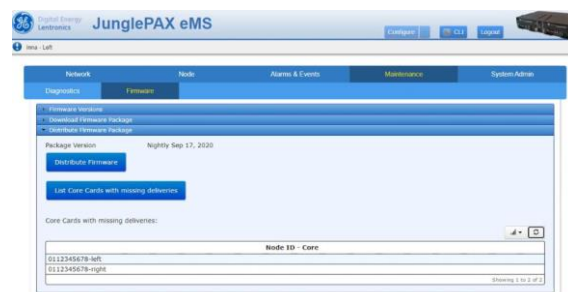
### 5. Simplified firmware upgrade

JunglePAX firmware distribution is a function<sup>1</sup> of the embedded software controller (eSWC) used by customers to control and enforce synchronization of information across the JPAX network.
