JunglePAX – Release Notes

Firmware Package p/n 90000-01
Version: 1.14a
Release Date: June 14th, 2019
Type of Release: Production Release

Lentronics JunglePAX

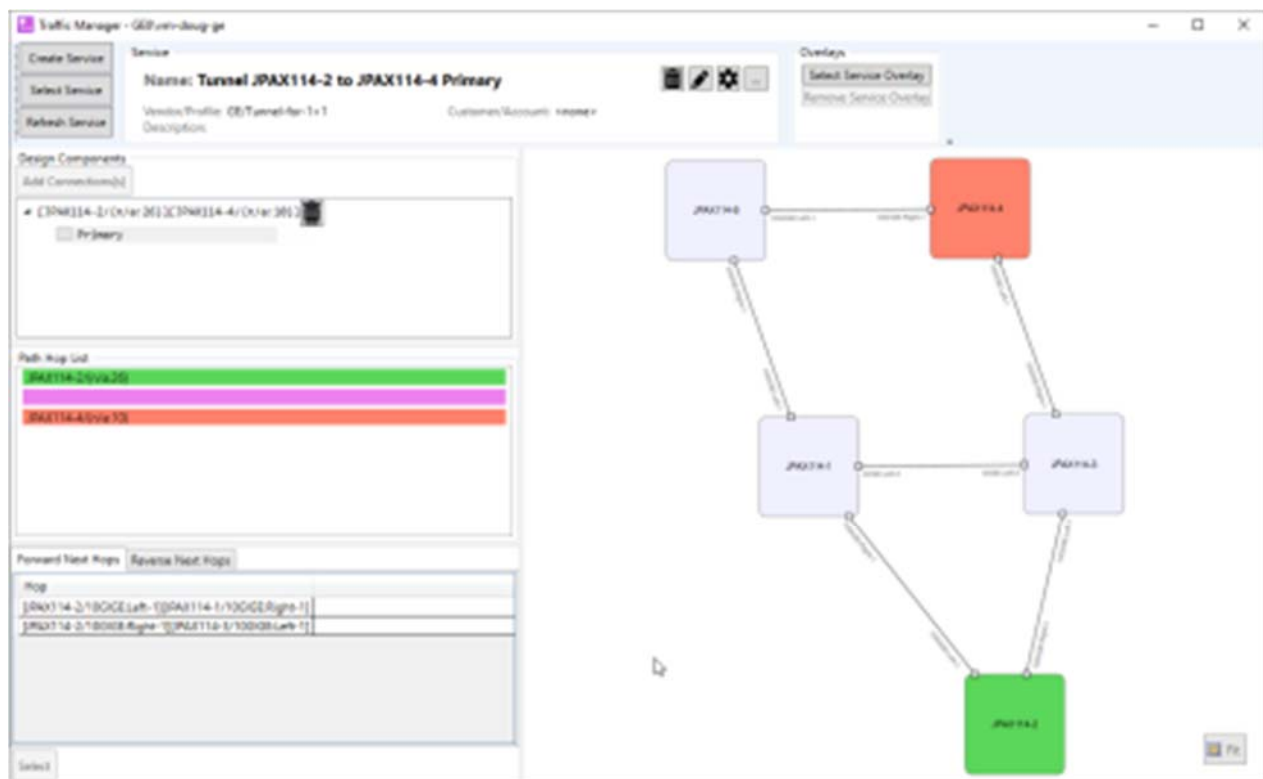
With the release of GE's Advanced NMS solution (90000-50, -50/G, -51 and -51/G), JPAX NMS ports now support routing on OSPF/IPv6 to facilitate a network-wide connectivity scheme from a single gateway node. Customers can now monitor their entire JunglePAX network from any NMS port at any node in the JunglePAX network with this licensed NMS software. Edge to Edge provisioning is also now supported through the NMS interface, significantly simplifying the process of creating tunnels and services.

Screen shot of GE's Advanced NMS Provisioning Manager
